**Western Juniper Management
Effectiveness Monitoring
Phase II Final Report**

CSR Natural Resources Consulting, Inc.

November 15, 2007

**OWEB Juniper Treatment
Effectiveness Monitoring
Phase II Final Report**

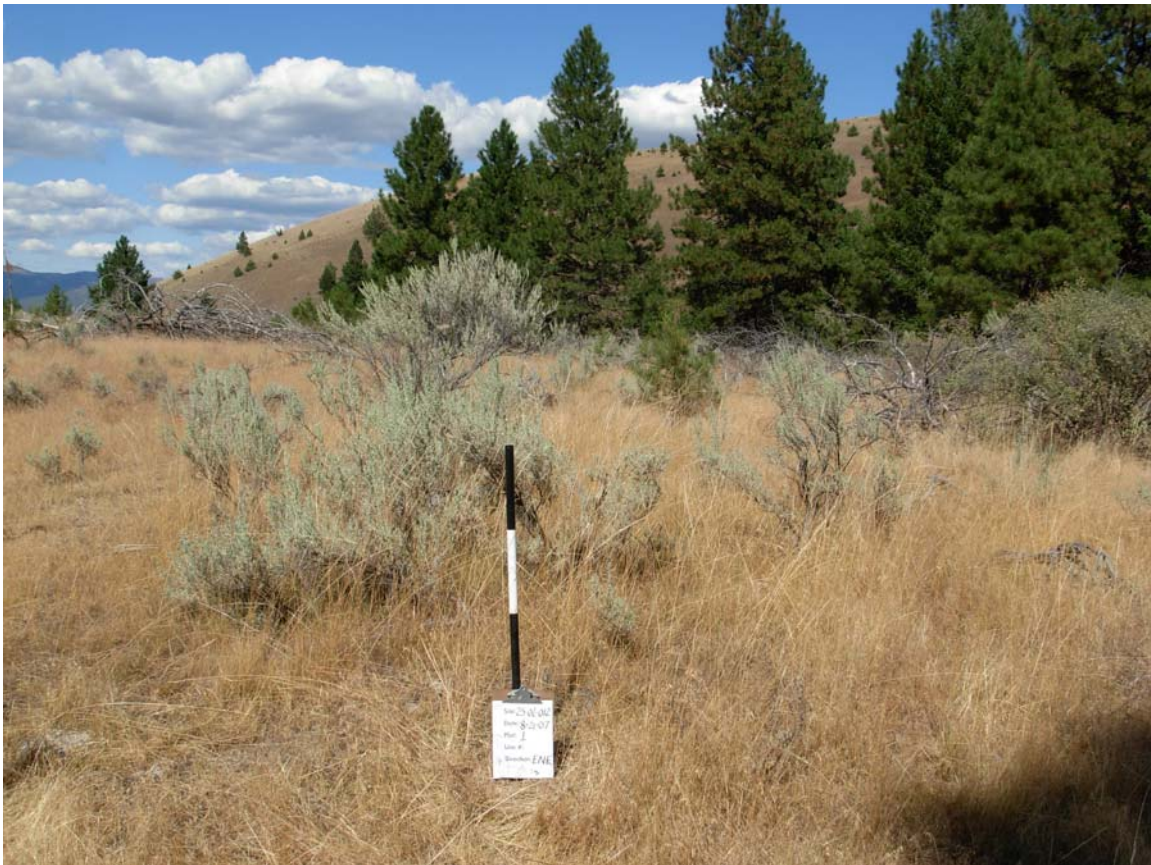
Photo of Post-treatment Conditions:

Changes in Plant Community Composition: Based on photographs of pre-treatment conditions, evidence of shrub die-off and limited amounts of deep-rooted perennial grasses, it is thought that juniper encroachment on the treatment site was at Phase III of juniper woodland succession (Miller, et al. 2005). The current plant community is dominated by annual grasses: cheatgrass, ventenata and six-week fescue.

Changes to Soil Surface Conditions: Prior to treatment, juniper encroachment and successional development had reached the point where the loss of native understory vegetation allowed full occupation of the site by annual grasses. Consequently, litter accumulation (82 percent cover) provides soil surface protection from raindrop impact, and contributes to soil surface organic matter.

Changes to Site Hydrology: Flat terrain and litter accumulation at the soil surface ensure the infiltration of most moisture received on the site. Juniper removal is expected to have significantly reduced the evapo-transpiration of stored soil moisture.

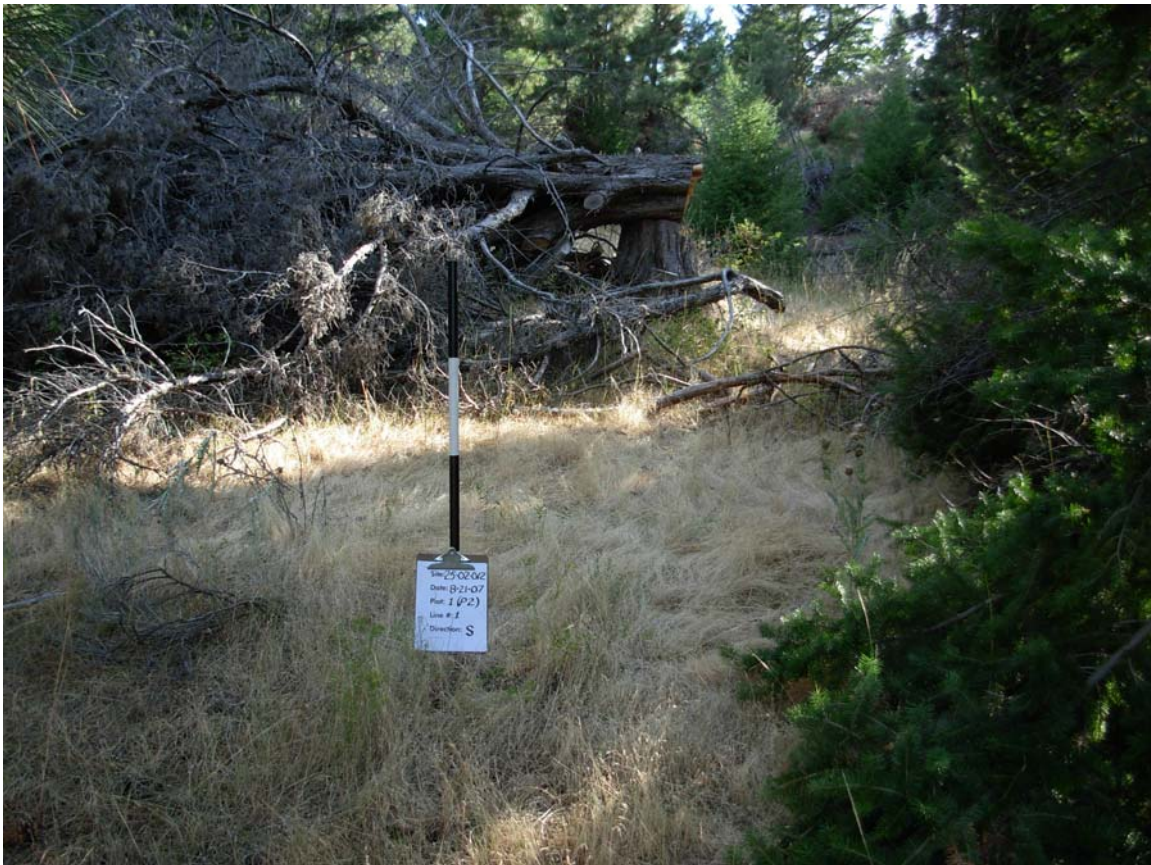
Photo of Post-treatment Conditions:

Changes in Plant Community Composition: Based on photographs of pre-treatment conditions, evidence of shrub die-off and limited amounts of deep-rooted perennial grasses, it is thought that juniper encroachment on the treatment site was at Phase III of juniper woodland succession (Miller, et al. 2005). The current understory plant community is dominated by annual grasses: cheatgrass, ventenata and six-week fescue.

Changes to Soil Surface Conditions: Prior to treatment, juniper encroachment and successional development had reached the point where the loss of native understory vegetation allowed full occupation of the site by annual grasses. Consequently, litter accumulation (76 percent cover) provides soil surface protection from raindrop impact, and contributes to soil surface organic matter.

Changes to Site Hydrology: Litter accumulation at the soil surface appears to detain overland flow and promote the infiltration of most moisture received on the site. Juniper removal is expected to have reduced the evapo-transpiration of stored soil moisture.

Post-treatment: Soil stability: Functioning
Hydrologic Function: Functioning-at-risk
Biotic Integrity: Non-functioning

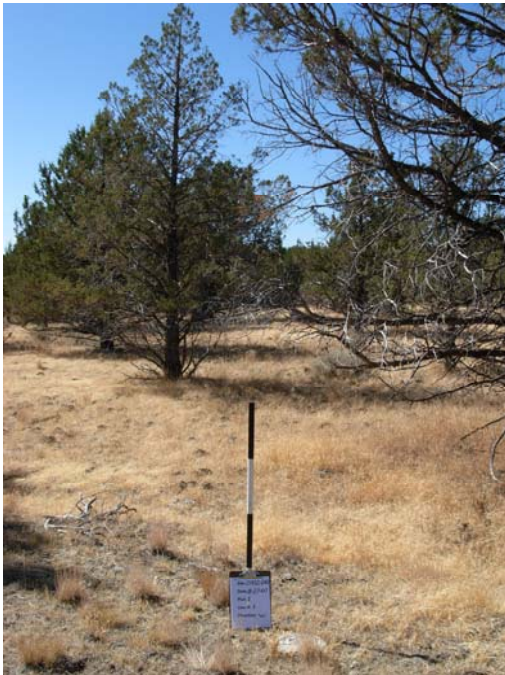
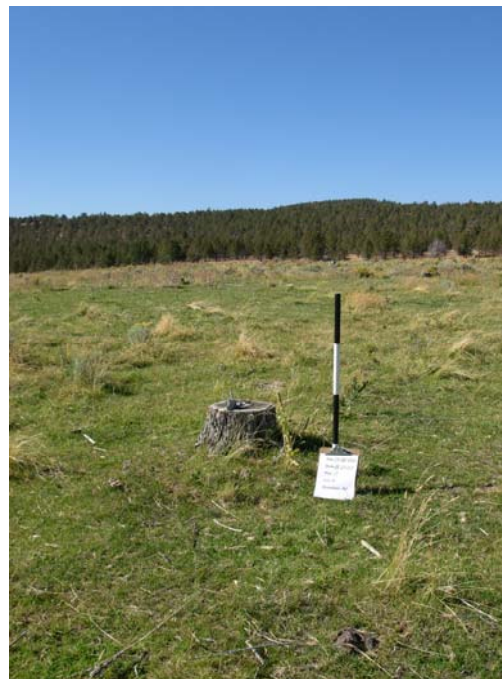
Photo of Pre- and Post-treatment Conditions:

Changes to Soil Surface Conditions: Accumulated plant litter and stones comprised about 95 percent of the soil surface cover on the untreated comparison area. No bare soil was observed. In the treatment area, foliar cover was observed to be about 97 percent, with 3 percent or less bare soil.

Changes to Site Hydrology: There was evidence of active flow paths and overland flow in the untreated area. In the treatment area, there was evidence of past gullying, presumably from concentrated flows from the upslope sites. These shallow gullies (one foot deep or less) were fully vegetated and stable. No evidence of overland flow was observed in the treatment area. It is presumed that the removal of juniper has reduced the evapo-transpiration of soil water.

Photo at left is of the untreated comparison area immediately upslope of the treatment area. Photo at right is of the treatment area, seeded to a pasture mix and irrigated. August 27, 2007.

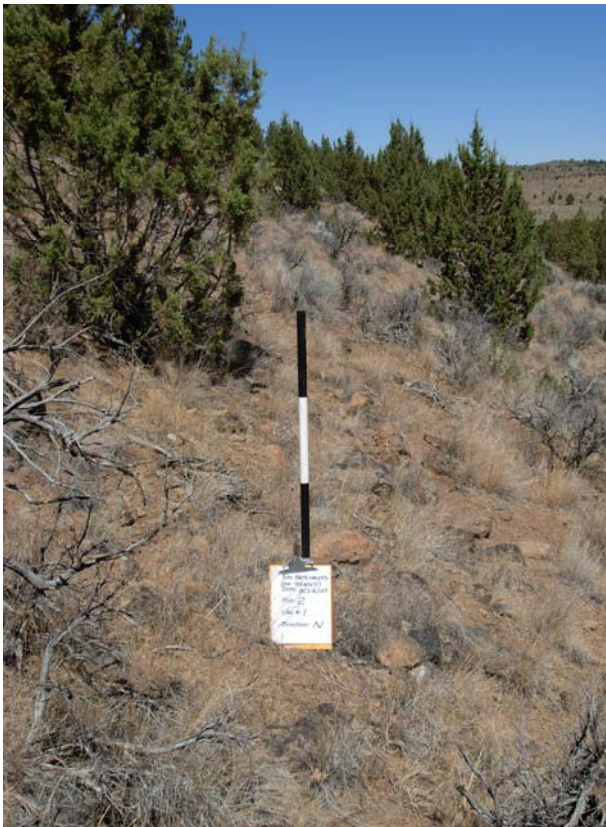
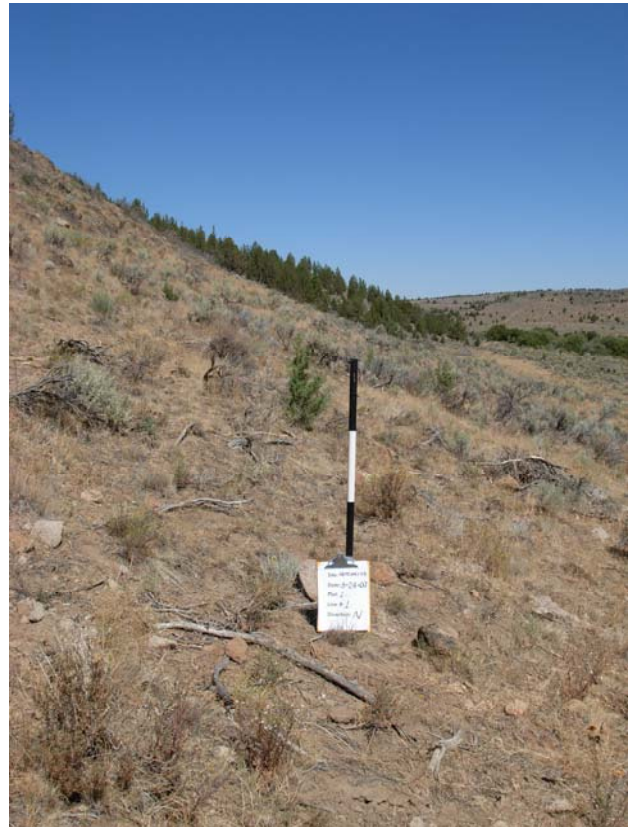
Photos of Pre- and Post-treatment Conditions:

Changes to Soil Surface Conditions: Juniper encroachment and successional development in the untreated area has reached the point where the loss of understory vegetation is reducing plant cover, resulting in excessive amounts of bare soil, increasing the risk of overland flow and soil erosion. Current spring (April through May) grazing use of the treated area is disturbing the soil surface and maintaining levels of bare soil similar to those in the untreated area. Annual grazing in the treatment area appears to be preventing the accumulation of plant litter. Plant litter in the untreated area was measured at 54 percent, while in the treated area; plant litter was measured at 20 percent.

The photo on the left shows an untreated reference area, note shrub die-off. The photo on the right shows the grazed treated area with the untreated reference site in the distance. August 24, 2007.

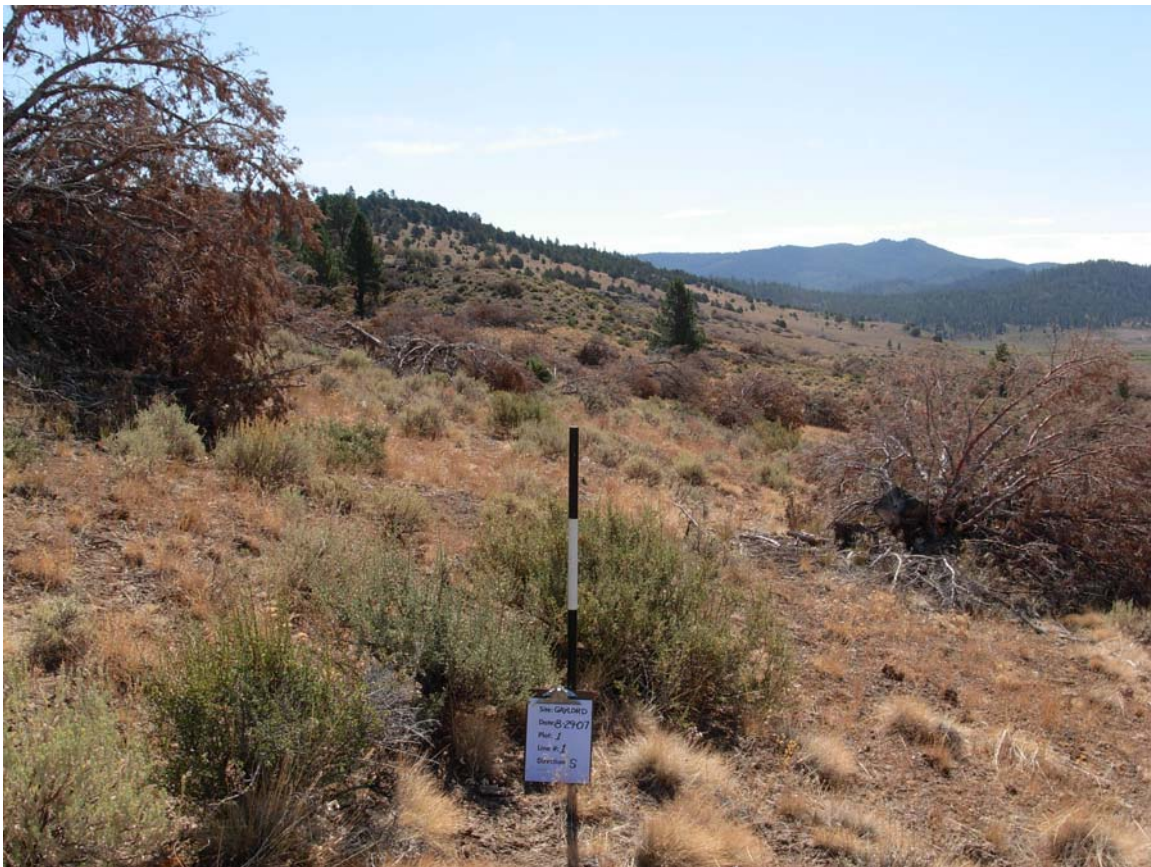
Photo of Post-treatment Conditions:

Changes in Plant Community Composition: Measurements of juniper duff (leaf litter) cover in the treatment area indicate a pre-treatment juniper canopy of about 10 percent and the trees ranged from 15 to 20 feet in height. When considered in combination, juniper canopy cover and height indicate juniper woodland succession at Phase II (Miller, 2005). At this stage of succession on the moderately deep soils in the treatment area, shrubs would become stressed, their growth slowed and some shrub die-off would be expected and was observed. New leader growth of 8 to 10 inches on antelope bitterbrush in the treated area was considered exceptionally good. Grasses and forbs occurred in the proportions and amounts expected for the site.

Changes to Soil Surface Conditions: Juniper encroachment and successional development had not reached the point where the loss of understory vegetation resulted in excessive amounts of bare soil. While bare soil was somewhat common on the site, it was within the range expected on a west-facing slope. Plant litter has been accumulating on the soil surface since the time of treatment.

Post-treatment: Soil stability: Functioning
Hydrologic Function: Functioning
Biotic Integrity: Functioning

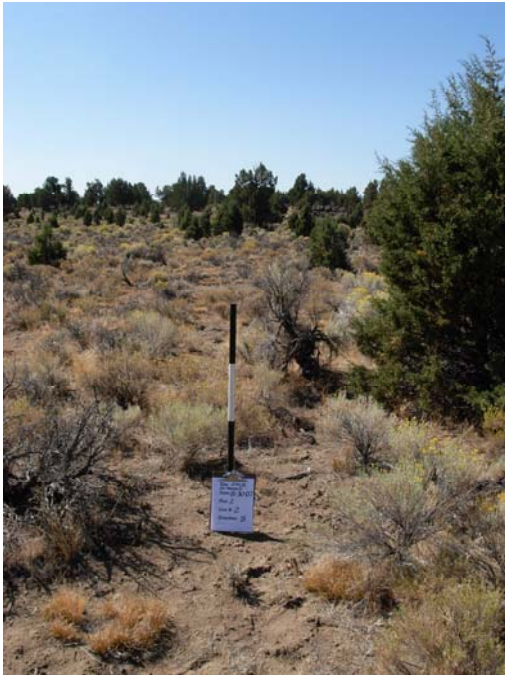
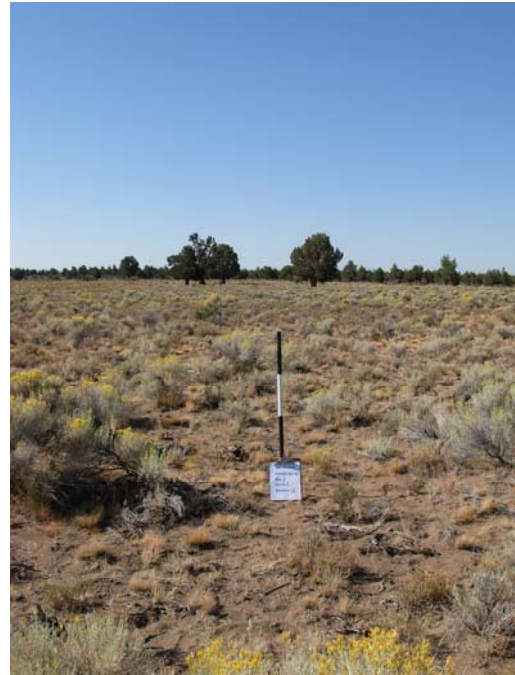
Photos of Pre- and Post-treatment Conditions:

Changes in Plant Community Composition: Juniper density and apparent tree age in the untreated comparison area indicate a Phase I of woodland succession (Miller, et al. 2005), while shrub mortality, reduced grass density and the amount of bare soil are at levels expected in late Phase II or early Phase III. It is suspected that a dense layer of lake deposited volcanic ash restricts the deep percolation of soil moisture and limits plant root penetration to the upper soil profile. As a result, strong competition for moisture may be occurring in the upper soil profile. Transects and observation indicate a clear difference in grass density, vigor and production between the treated and untreated sites. Rabbitbrush has increased while sagebrush has decreased.

Changes to Soil Surface Conditions: Juniper encroachment had reached the point where the loss of understory vegetation resulted in excessive amounts of bare soil. Grass density and cover (reconstructed after grazing) indicate a significant increase in soil surface protection from wind erosion.

The photo at left represents the untreated comparison area. The photo at right is of the treated area.

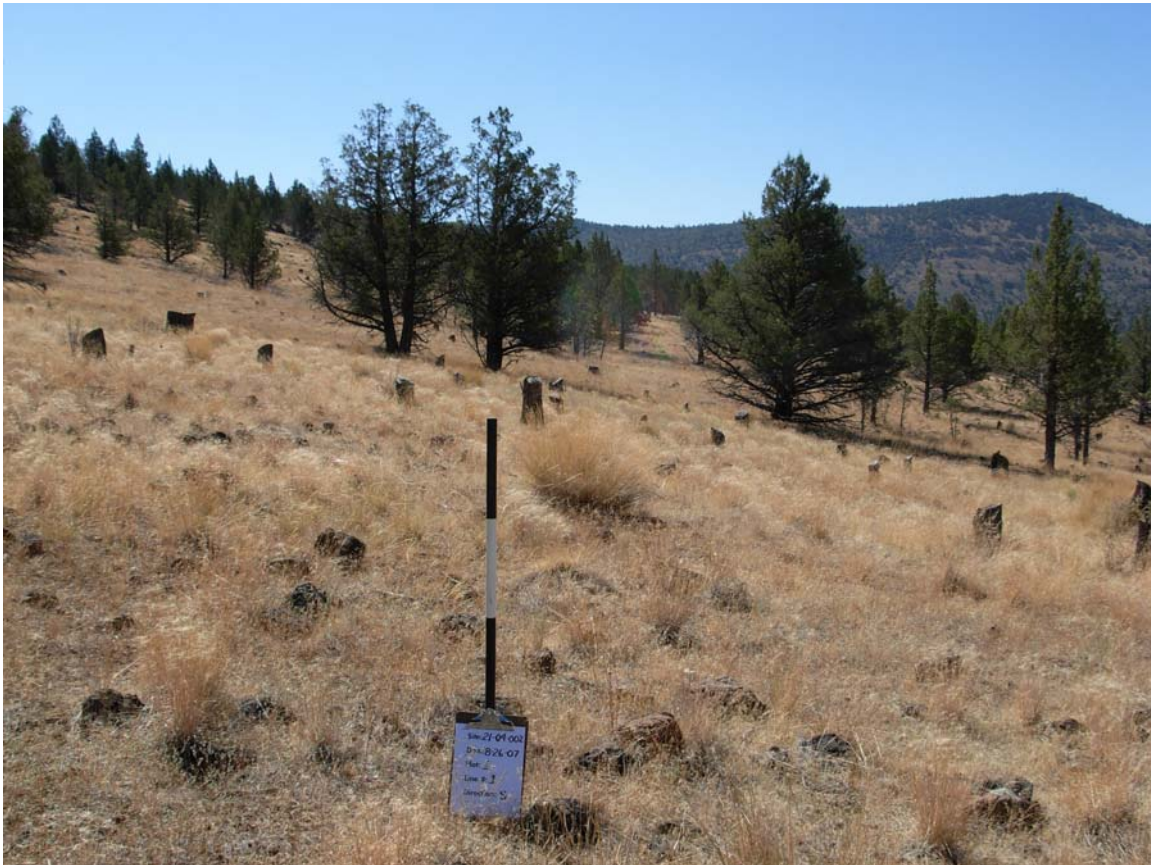
Photo of Post-treatment Conditions:

Changes in Plant Community Composition: Based on photographs of pre-treatment conditions, evidence of shrub die-off and limited amounts of deep-rooted perennial grasses, it is thought that juniper encroachment on the treatment site was at Phase III of juniper woodland succession (Miller, et al. 2005). Of the grass component of the current plant community, approximately 30 percent is made up of deep-rooted perennial grasses including, in order of occurrence: squirreltail, Thurber needlegrass, and bluebunch wheatgrass. Annual grasses (cheatgrass, Japanese brome, and medusahead) comprise the remaining 70 percent of the grass cover.

Changes to Soil Surface Conditions: Prior to treatment, juniper encroachment and successional development had reached the point to where there was a significant reduction of native understory vegetation and, according to the project application; there was a significant amount of bare soil beneath the trees. Tree removal allowed to occupation of the bare areas by annual grasses. Consequently, annual plant litter accumulation (about 40 percent cover) provides soil surface protection from raindrop impact, and contributes to soil surface organic matter.

Changes to Site Hydrology: Litter accumulation at the soil surface promotes the infiltration of most moisture received on the site. Juniper removal is expected to have significantly reduced the evapo-transpiration of stored soil moisture. Some active flow paths were observed in the treatment area. The retention of slash in these flow paths would have detained overland flow and trapped sediment

Post-treatment: Soil stability: Functioning
Hydrologic Function: Functioning
Biotic Integrity: Functioning-at-risk

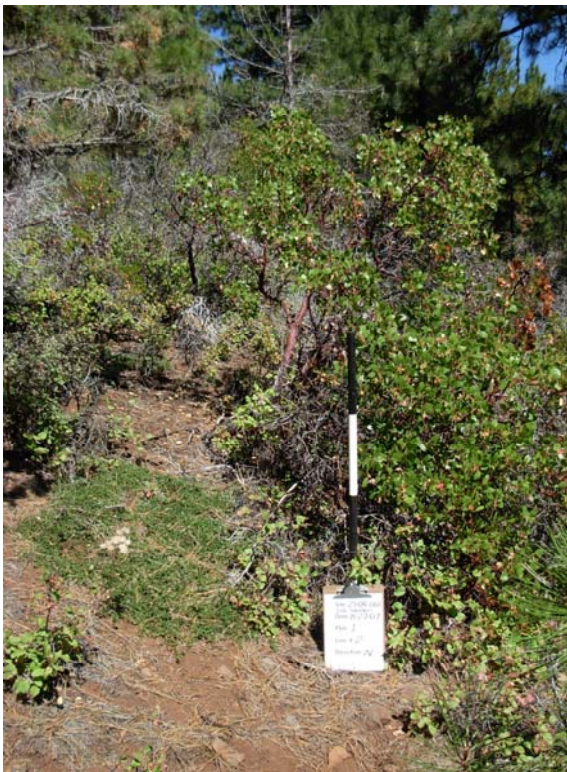
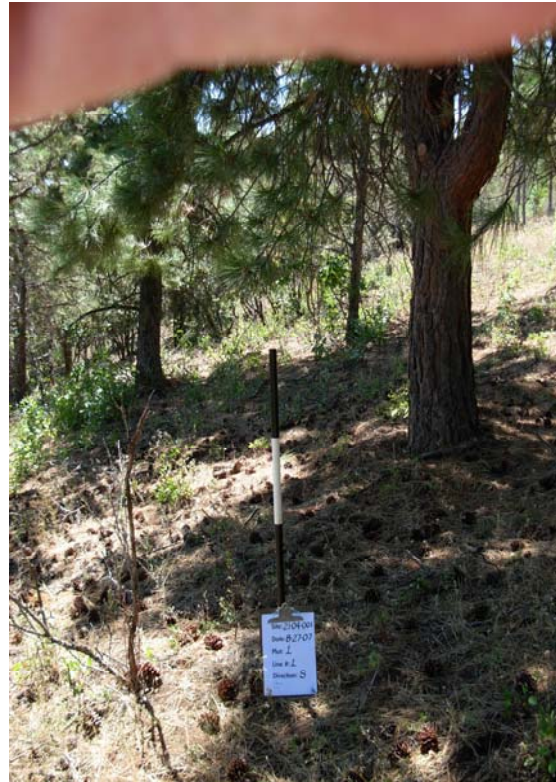
Photos of Pre- and Post-treatment Conditions:

Changes to Soil Surface Conditions: The treatment resulted in an increase in bare ground: 0 in the untreated area, 16% in the treatment area.

The photo at the left is representative of the area before treatment. The photo at right is of the treatment area. August 27, 2007

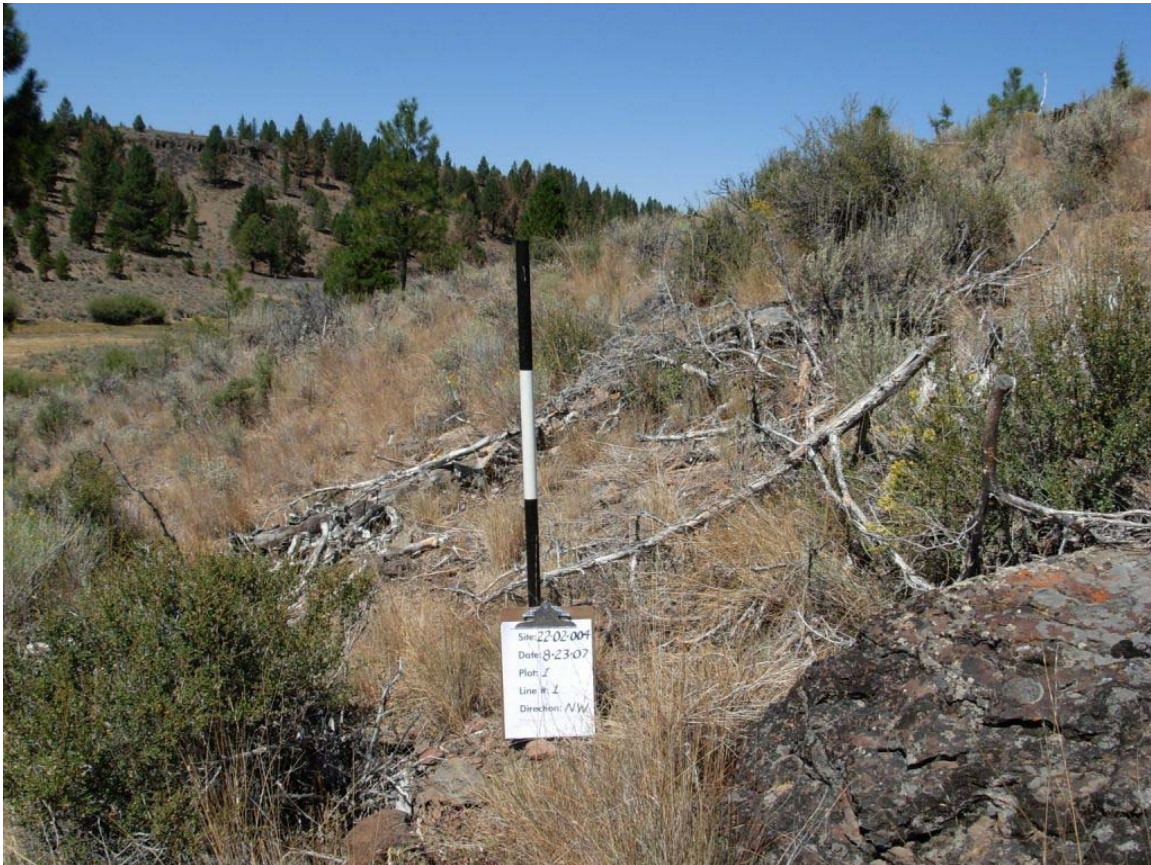
Photo of Post-treatment Conditions:

Biotic Integrity: Functioning

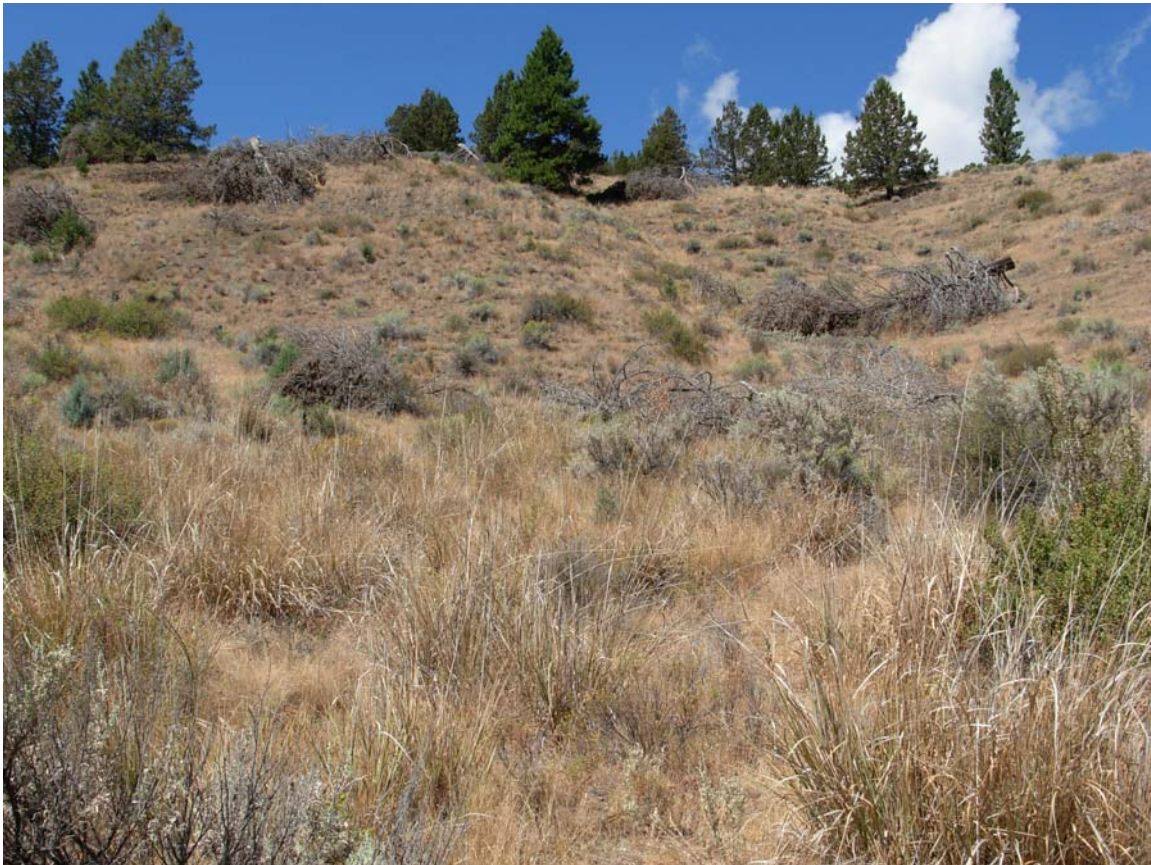
Photo of Post-treatment Conditions:

Biotic Integrity: Functioning-at-risk (upward trend)

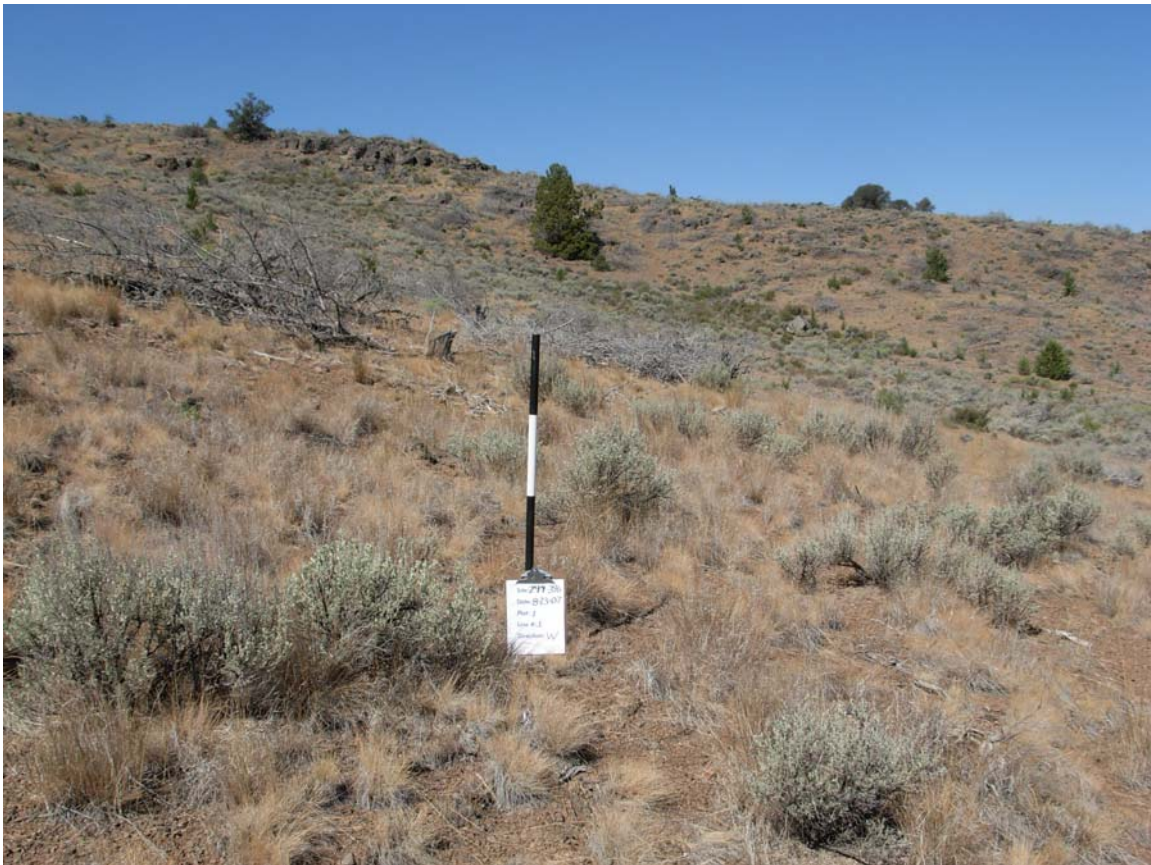
Photo of Post-treatment Conditions:

Post-treatment: Soil stability: Functioning-at-risk (Upward trend)
Hydrologic Function: Functioning-at-risk (Upward trend)
Biotic Integrity: Functioning

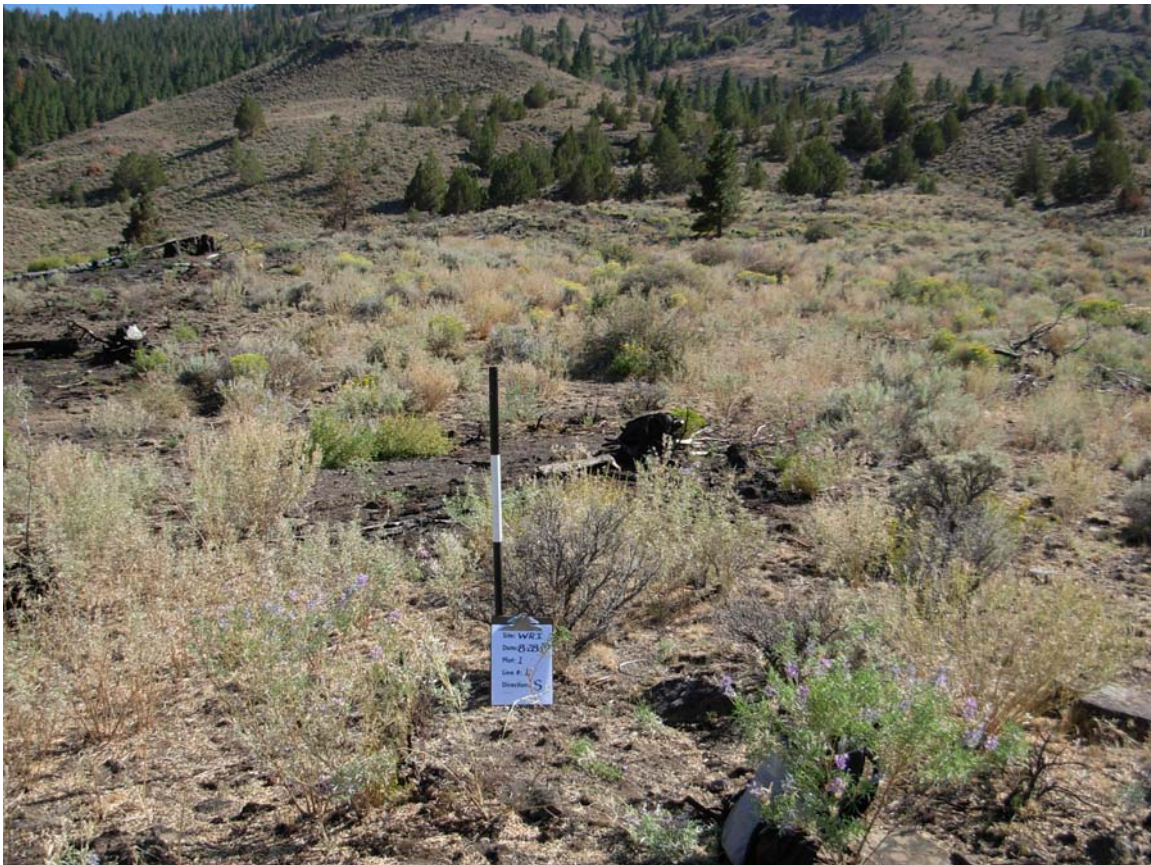
Photo of Post-treatment Conditions:

Post-treatment: Soil stability: Non-functioning
Hydrologic Function: Non-functioning
Biotic Integrity: Non-functioning
